The Submarine Division of the Naval Safety Center Presents:

FLASH

Factual Lines About Submarine Hazards

March 2000 – June 2000

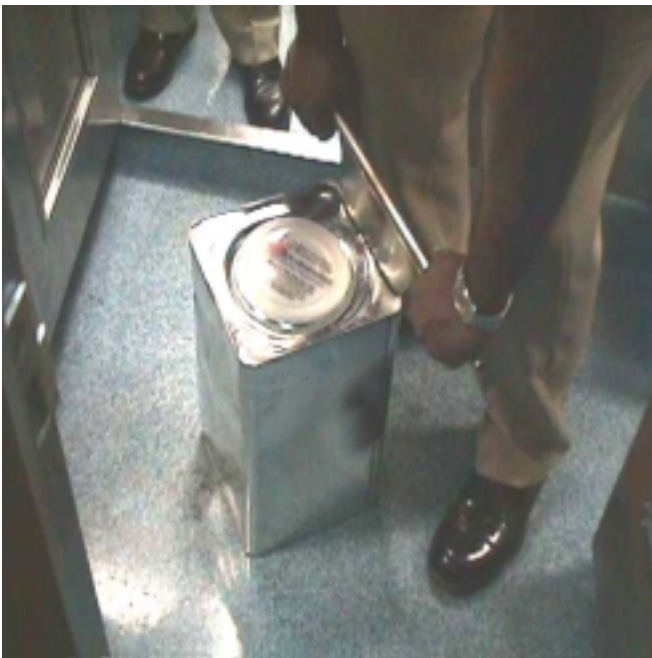
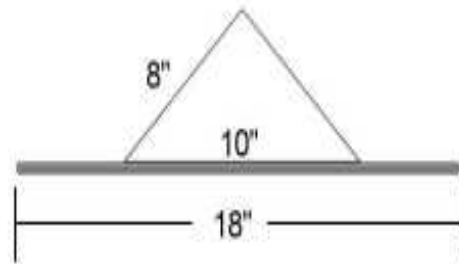
During a visit to USS Norfolk (SSN 714), our submarine survey team was introduced to a tool that has enabled their cooks to all but eliminate the lacerations that result from

improperly opened cans. It's a very simple device, with no moving parts. Although it looks sort of evil, it's perfectly harmless. The edges and the point are not sharp enough to cut someone, but when you place its point on the edge of a can lid and apply a little body weight, it cuts through the lid like a hot knife through butter. And as it cuts, the edges of the can are turned downward. The lid edges are turned

downward, as well, but it should be handled with care (with cut resistant gloves) until disposed of safely.

The best news about this tool is that you can make it yourself (or have it made for you). The USS Norfolk used a round stainless steel 3/4 inch bar stock for the 'spine' (approximately 18 inches long). The stainless allows you to easily keep it clean and sanitized. The triangle at the base where it is spot welded onto the spine is the width of the side of the square can (approximately 10 inches). The material is 4 or 6-gauge stainless steel.
